# NASA/TM-2006-214082

# Investigation of Tapered Roller Bearing Damage Detection Using Oil Debris Analysis

Paula J. Dempsey Glenn Research Center, Cleveland, Ohio

Gary Kreider and Thomas Fichter The Timken Company, North Canton, Ohio Since its founding, NASA has been dedicated to the advancement of aeronautics and space science. The NASA Scientific and Technical Information (STI) Program Office plays a key part in helping NASA maintain this important role.

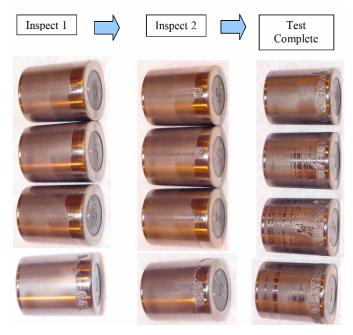
Photos of the damaged components were taken at each inspection interval and at test completion. Photos of the damage are shown in figures 3 through 6. After the first inspection interval, spalling was observed on several of the rollers and peeling was observed on the cup and cone. The spalls on the rollers increased in size during the second inspection, but the peeling on the cup and cone did not appear to increase significantly. At test completion, the spalls on the rollers increased significantly, the peeling on the cup and cone did not change, spalling began to occur on the cone and cage damage was also observed. It should be noted that the cage material of all bearings tested was silver, and nonferrous particles were not analyzed during these tests.

Figure 3.—Test 1 roller damage.

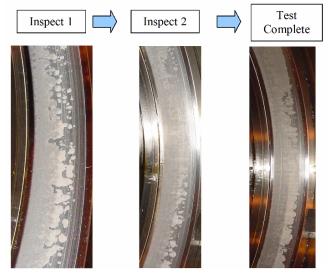
Figure 4.—Test 1 cup damage.

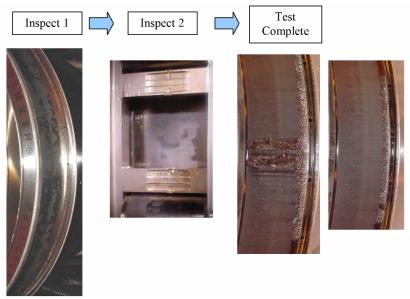
Figure 5.—Test 1 cone damage.

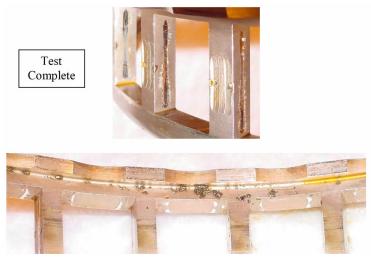
Figure 6.—Test 1 cage damage.

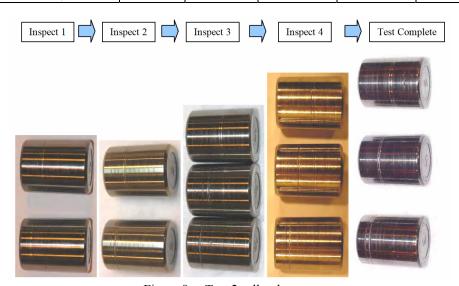
Photos of the damaged components were taken at each inspection interval and at test completion. Photos of the damage are shown in figures 8 to 12. After the first inspection interval, wear lines were observed on the rollers, and the dents slightly increased in size. During inspection 2, small pits were observed on the cup, no significant damage was observed on the rollers. At inspection interval 3, a large spall was observed on the cone and a few more wear lines

Figure 8.—Test 2 roller damage.

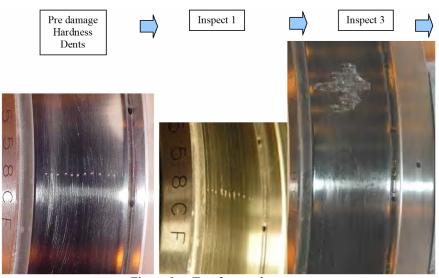
on the rollers. At inspection interval 4, the cone spall increased in size. At test completion the cone spall doubled in size, the small pits observed on the cup at inspection 2 remained the same, and cage damage was observed.

Figure 9.—Test 2 cone damage.

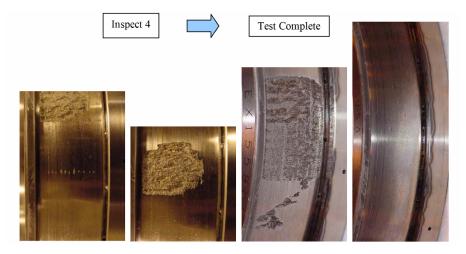
Figure 10.—Test 2 cone damage.

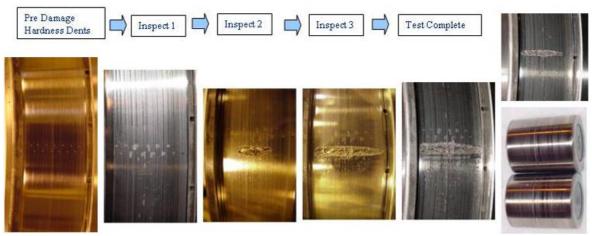
Photos of the damaged components were taken at each inspection interval. Photos of the damage are shown in figure 14. After the first inspection interval, no damage was observed on the bearing. In order to expedite failure, the raceway was again damaged near the original predamage hardness dents. During inspection 2, pitting damage began to occur near the location of the predamage dents and damage placed on the cone during inspection 1. At

inspection interval 3, the damage observed on the cone during inspection 2 grew into a large spall. At test completion, the initial spall grew slightly and another spall occurred 90° from the original spall and wear lines were observed on the rollers.

Figure 14.—Test 3 cone damage.
